Failure investigation of a tie rod end of an automobile steering system

A.H. Falah *, M.A. Alfares, A.H. Elkholy

Mechanical Engineering Department, Kuwait University, P.O. Box 5969, Safat 13060, Kuwait

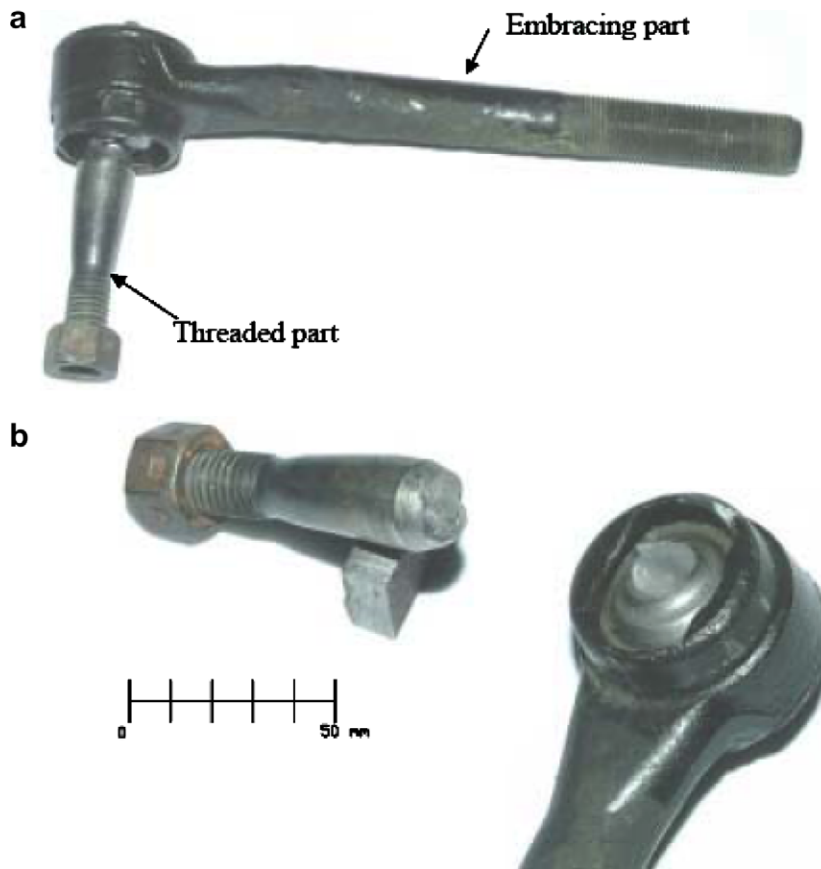
Fig. 3. Parts of fractured tie rod end (a) assembled and (b) separated.

of such vehicles every year and they were, and still are, running fine all over the world without any reported serious failure. The dealer attributed the accident to careless driving behavior that resulted in a loss of control over the vehicle, which in turn hit the guard rail and led to vehicle damage. To settle the dispute, it was decided to undertake a thorough failure analysis investigation of all components of the steering mechanism to determine the cause of failure. All steering components were found intact though badly bent, except for the outer tie rod end which was fractured at the throated area of its threaded part. The embracing part of the outer tie rod end, however, was intact, except for two scars at its rim that could have happened when the threaded part broke into two pieces. The general appearance of the parts of the failed tie rod end is shown in Fig. 3a, where the two fragmented pieces of the threaded part were brought together to show how the tie rod end appeared before failure. Fig. 3b shows the two fractured parts separated. Fig. 4 gives the visual appearance of the embracing part and one fragment of the threaded part, both facing up. It is clear that fracture took place at the throat area of the threaded part where stress is expected to be high due to reduced cross sectional area and stress concentration. Further examination of the threaded part was conducted to determine the exact cause of failure.

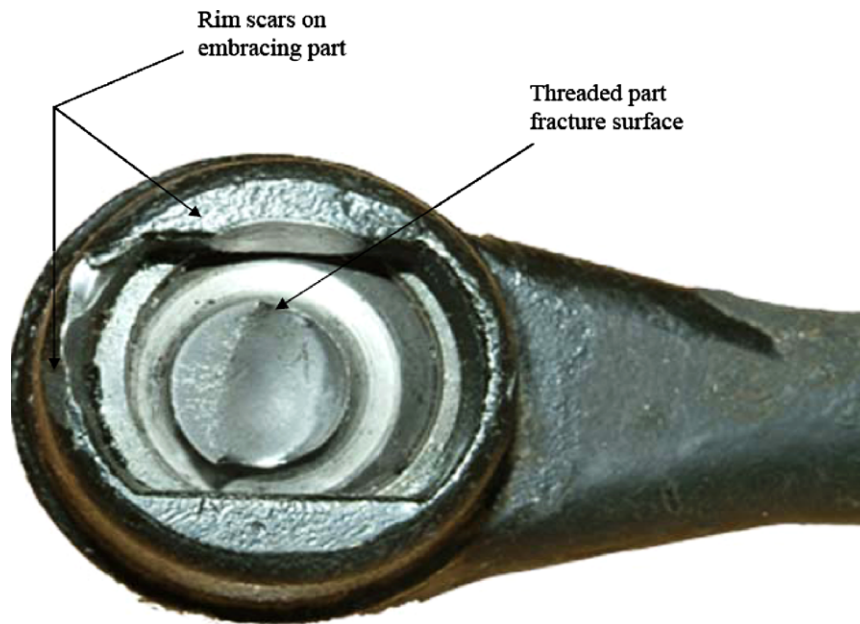
Fig. 4. Threaded part fracture surface and rim scars on embracing part.

It is evident from Fig. 4 that there exist two distinct areas on the fracture surface; one is smooth while the other is relatively rough. This is a typical fatigue fracture where crack originates at the edge of the smooth area and propagates towards the rough area, which represents final failure. On the other hand, the smooth area of the fracture surface is dominant as seen in Fig. 4. This indicates that the tie rod end took some time to break from the instant of crack initiation till complete fracture; i.e. a high cycle fatigue failure case. This proves that

the cause of the SUV accident was a lack of strength and low resistance to impact loads in the material of the threaded part of the tie rod end that initiated a crack and then took some time to reach complete separation.

From the above observation, it can be ascertained that failure was caused by high stress concentration at the throat area mainly due to inadequate chemical composition which contributed to reduction in material strength and lack of toughness. Under the cyclic loading produced from driving the SUV on regular and bumpy roads, fatigue cracks had initiated at these stress concentration points, namely the throat, leading to fracture of the part at the instant when the local stress exceeded the material strength. It should be mentioned, as well, that every so often, the increased noise and vibration due to crack propagation go unnoticed till failure unexpectedly occurs. In order to further improve the durability of the tie rod end to stand the applied loads, it is suggested to increase the cross-sectional area of the threaded part throat and to enlarge the fillet radius.

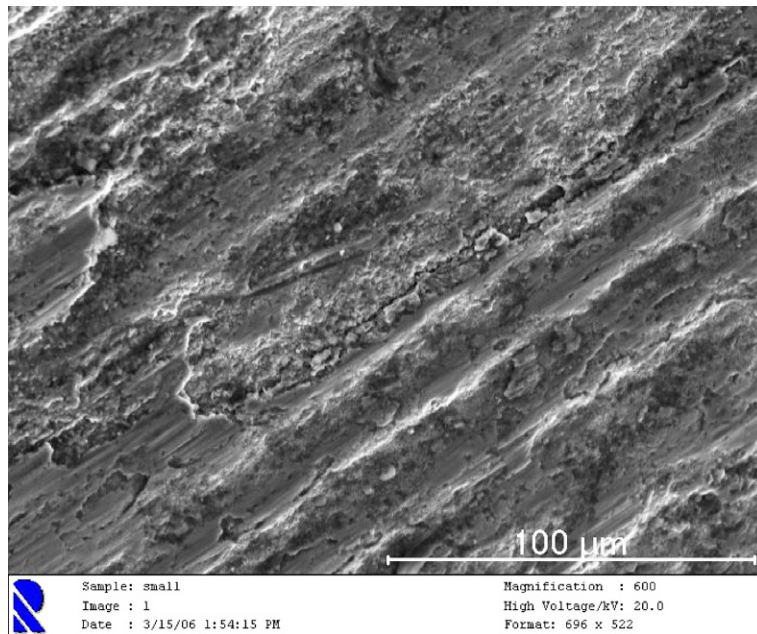
Fig. 5. SEM micrograph showing crack propagation region.

A specimen from the fractured surface was metallographically prepared and observed in a scanning electron microscope (SEM). Significant fatigue cracks were observed at the smooth area of the fracture surface. The origin of cracks was at the edge of the smooth area of the threaded part throat, suggesting that the stresses were highest at this region. Fig. 5 shows crack propagation on the fracture surface. Beach marks can be observed clearly which is a typical feature of fatigue failure [4].

The origin of the crack was surrounded by beach marks. Also, the fracture surface at the fatigue region had a smooth appearance with a rippled beach mark pattern which indicates that fatigue had initiated at one point of the circumference and then grown across the fracture area. A small area has a rough, jagged look where the last portion of the throat broke away. No corrosion media were found on fracture surfaces.

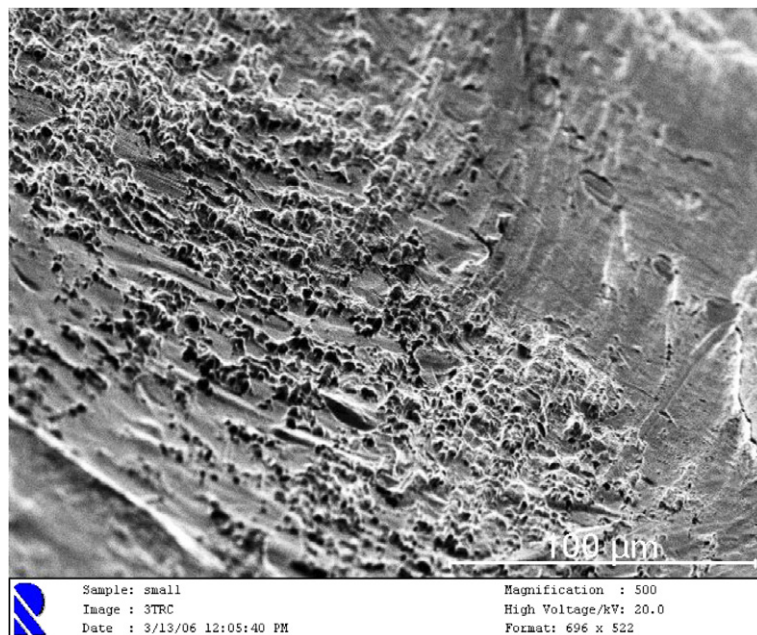
Fig. 6. SEM micrograph showing typical brittle fracture observed in final stage of crack propagation zone.

Brittle fracture was observed in the final stage at crack propagation as seen in Fig. 6. Fig. 7 shows the micrograph of the rough area of the fracture surface where variation of grain size combined with shallow dimples is evident. The light lines surrounding the grains in the figure indicate intergranular cracking that

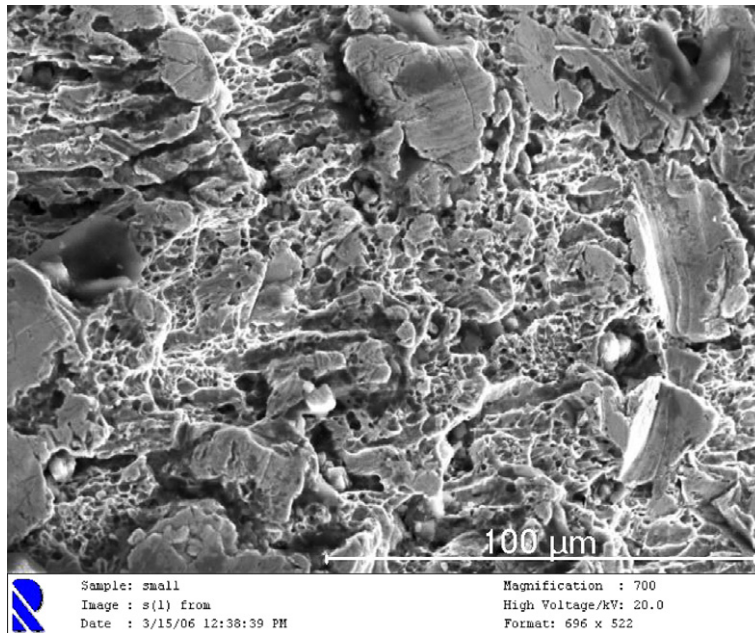
Fig. 7. SEM micrograph of the last portion of fracture surface to break away.

is usually observed with brittle fracture. A close-up of such grains revealed both intergranular and transgranular cracking at some locations as shown in Fig. 8.

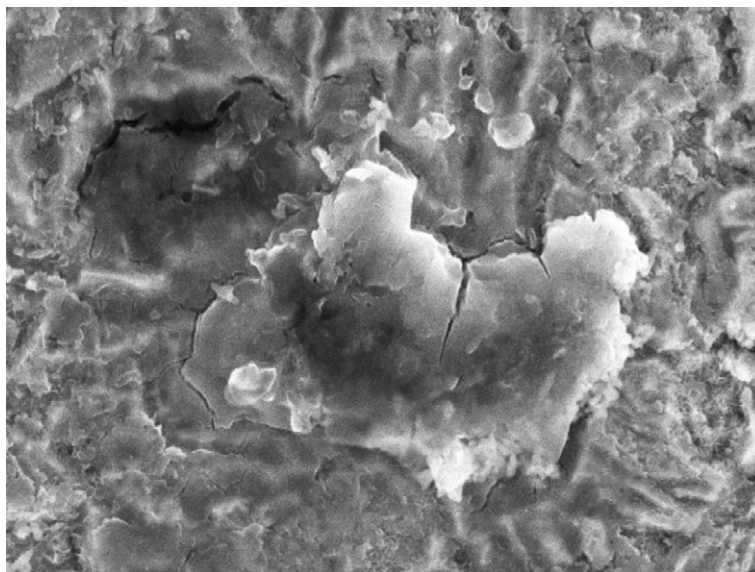
Fig. 8. Close-up showing both intergranular and transgranular cracking.

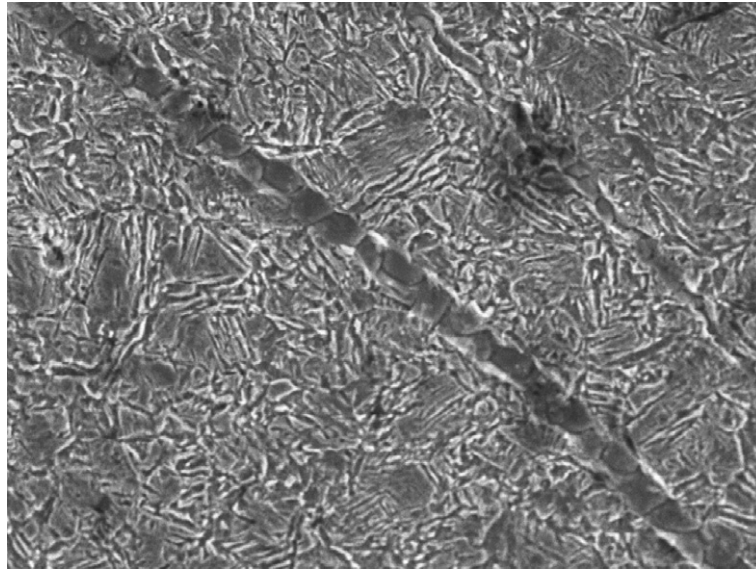
Fig. 9. Micrograph of thread part showing Pearlite (Finger prints Matrix) and α -Ferrite (sample was etched with 2% Nital).

Metallographic view of a sample cut from the threaded part after polishing and etching with 2% Nital solution is shown in Fig. 9. As shown, the microstructure consists of pearlite (finger print appearance) and ferrite (which appears dark). This is typical of unhardened low carbon steel. No abnormality was observed in the microstructure.
